RELIEF OF RESIDUAL STRESS IN STREAMLINE TIE RODS BY HEAT TREATMENT

By R. E. Pollard and Fred M. Reinhart
National Bureau of Standards

Washington
November 1941

TECHNICAL NOTE NO. 832

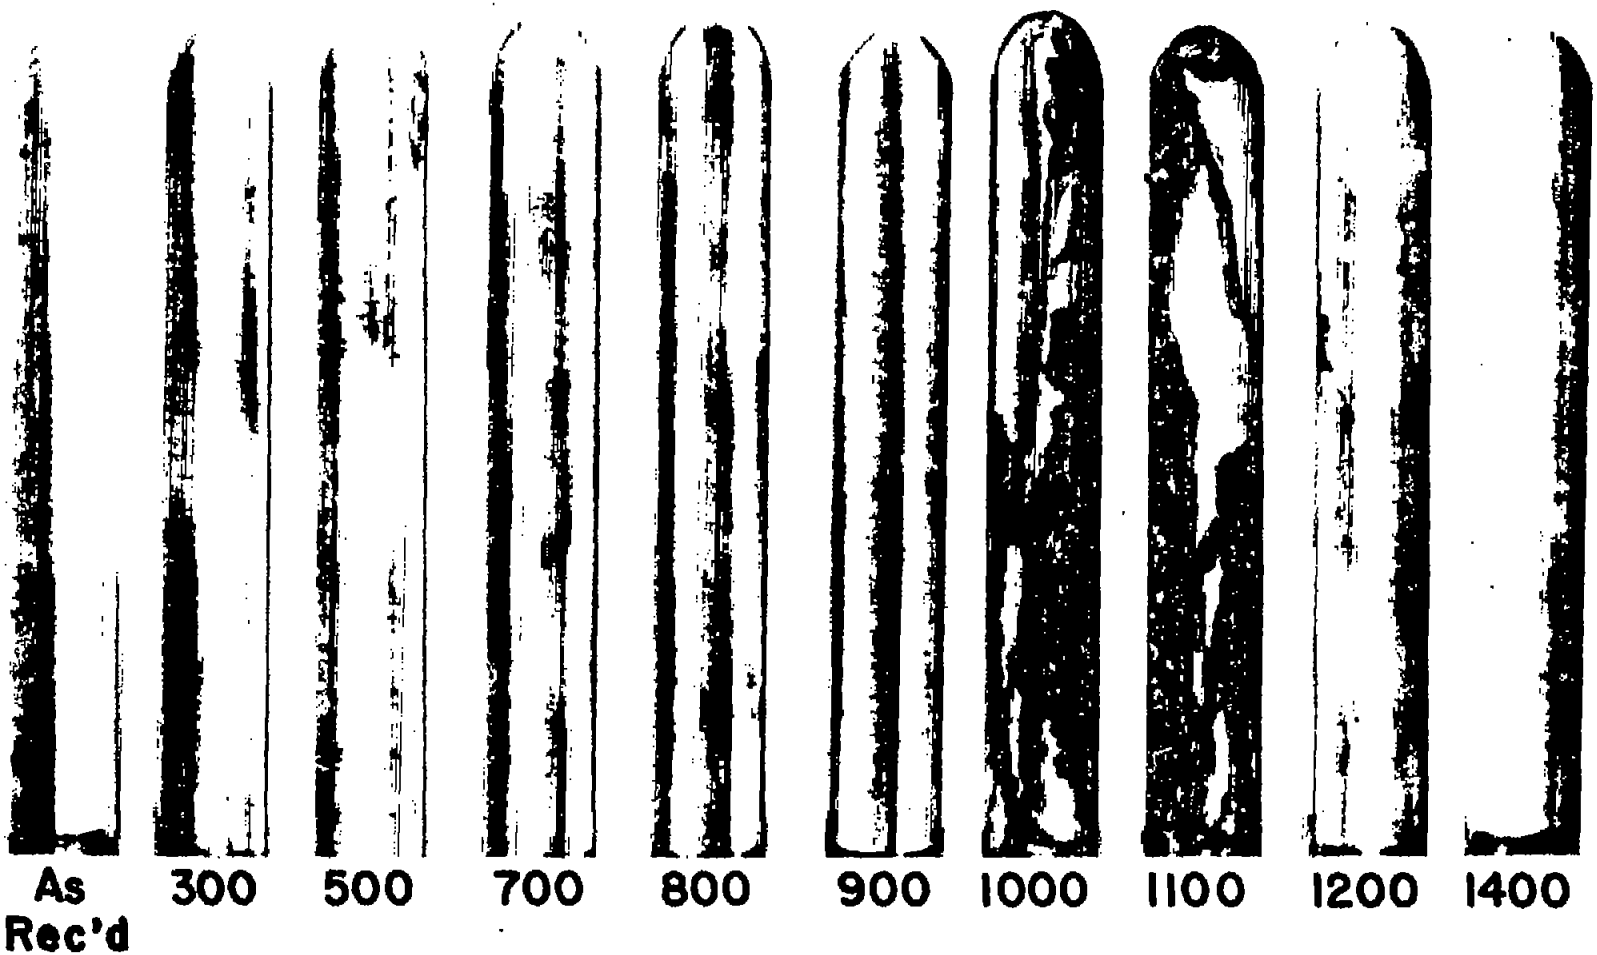
At the end of 1200 hours, specimens of E (18:8) material heated at temperatures below 1000° F showed only superficial staining with no evidence of progressive corrosive attack (fig. 11). The superficial stains, when present, were usually traceable to a slight attack at the ends. Specimens heated at 1000° and 1100° F developed rust stains within 24 hours. The corrosive attack then progressed steadily throughout the test. After 1200 hours, the specimens showed a considerable amount of pitting both at the ends and along the sides. The specimen heated at 1200° F showed only slight pitting after 1200 hours while the specimen heated at 1400° F was not attacked.

Figure 11.- 18-8 (Material E) - Heat-treated specimens after 1200 hours in salt spray (20 percent). Heating period, 30 minutes. x 7/8

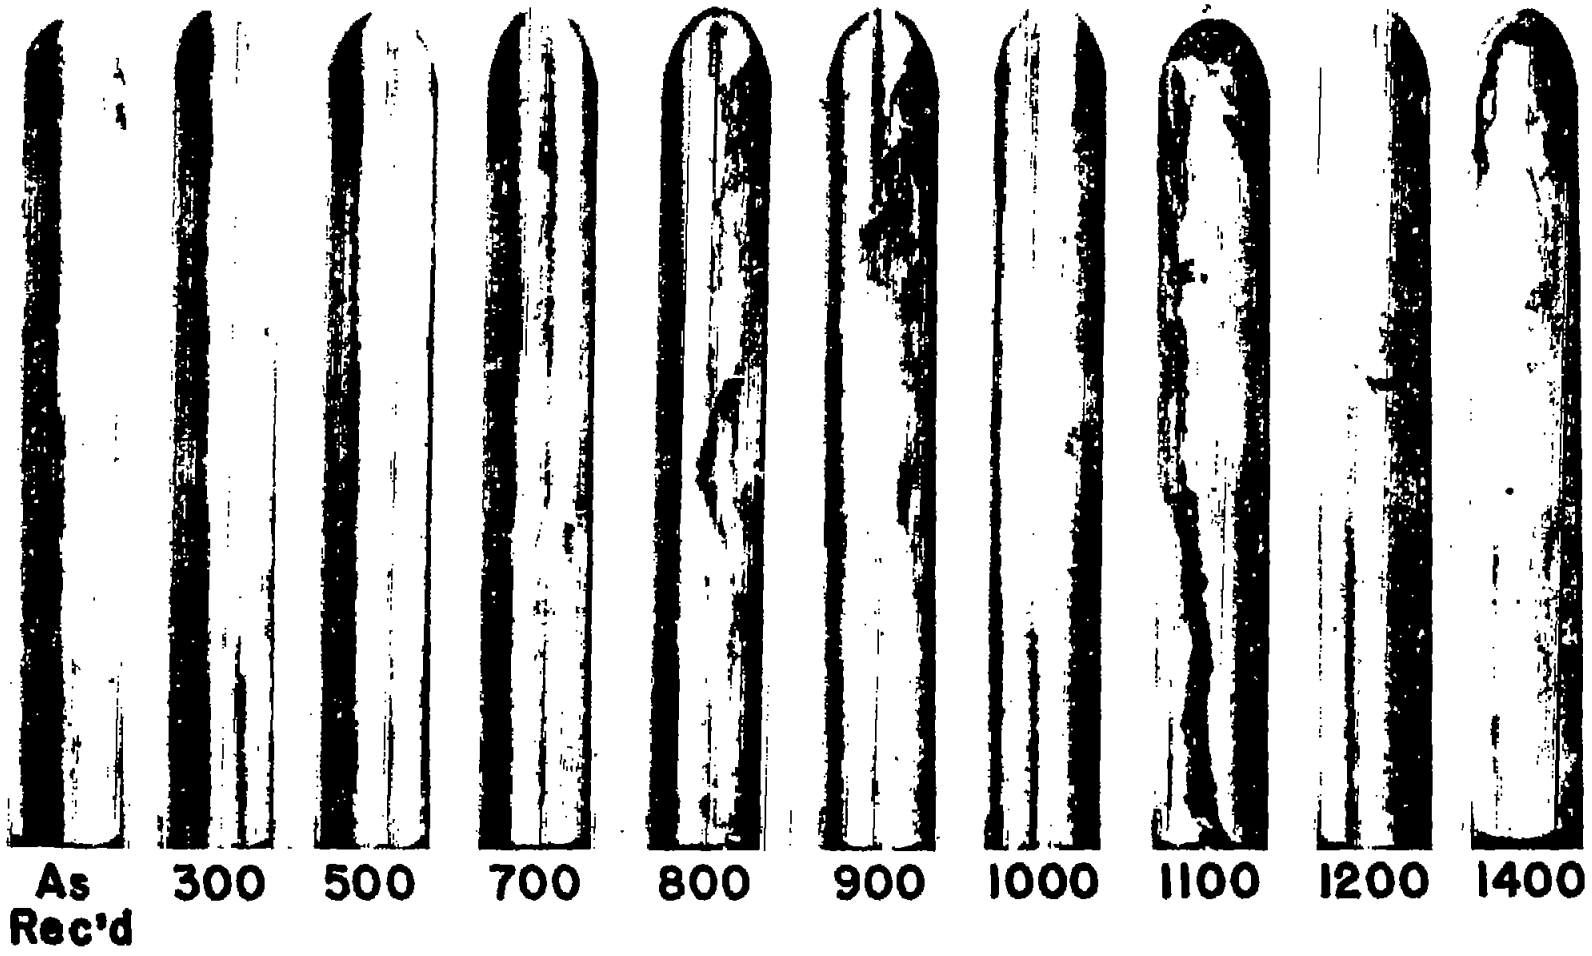
Specimens of titanium-treated material (H) heated at temperatures below 800° F showed only superficial stains after 1200 hours in the spray (fig. 12). The specimen heated at 800° F was considerably stained, but

showed only slight pitting at the rounded end. Specimens heated at 900° and 1100° F showed some etched and pitted areas along the sides as well as at the ends. The specimen heated at 1000° F showed no evidence of corrosion. The corrosive attack on specimens heated at 1200° and 1400° F was very slight.

Figure 12.- 18-8-Ti (Material H) - Heat-treated specimens after 1200 hours in salt spray (20 percent). Heating period, 30 minutes. x 7/8

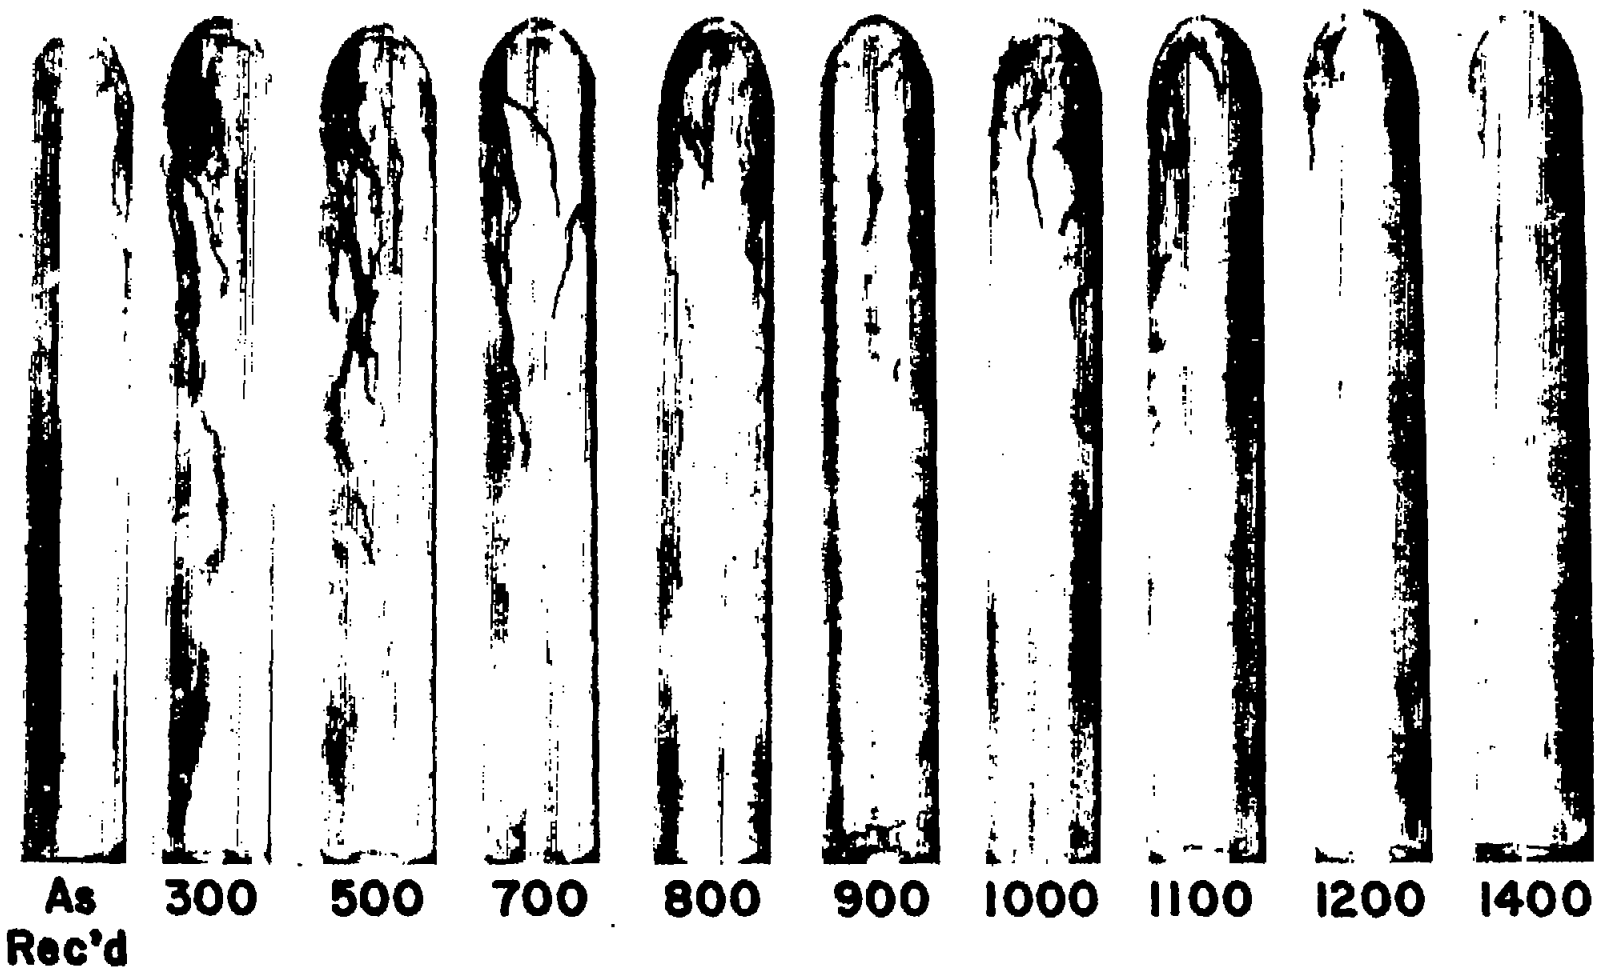
Specimens of columbium-treated (K) material heat-treated at different temperatures showed no marked differences in resistance to corrosion by the salt spray (fig. 13). All of them exhibited only superficial stains traceable to slight pitting attacks at the ends of the specimens. On removal of the stain, no evidence of attack was found in other areas.

Figure 13.- 18-8-Cb (Material K) - Heat-treated specimens after 1200 hours in salt spray (20 percent). Heating period, 30 minutes. x 7/8

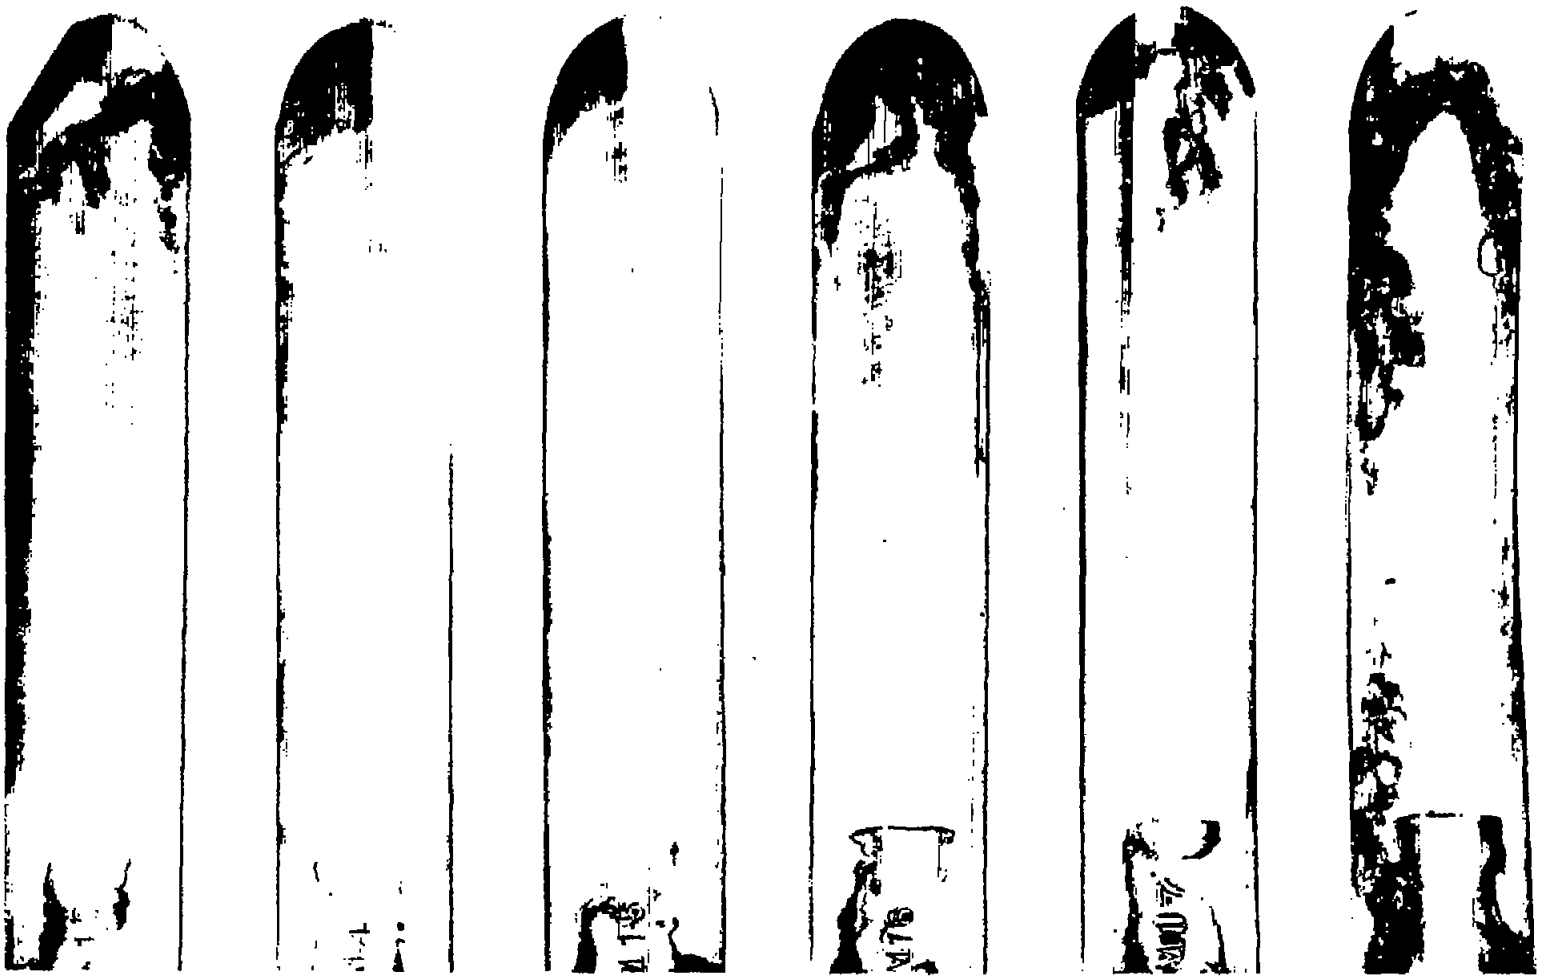
At the end of 1000 hours' exposure, heat-treated specimens of molybdenum-treated material (M) showed no appreciable staining and no evidence of progressive corrosive attack (fig. 14). The specimen exposed as received and that heated at 1000° F showed slight staining at the end of 24 and 48 hours, respectively. However, this initial staining seemed to be arrested at this point, and no evidence of increased corrosive attack was noted during the test.

Figure 14.- 18-8-Mo (Material M) - Heat-treated specimens after 1000 hours in salt spray (20 percent). Heating period, 30 minutes. x 1

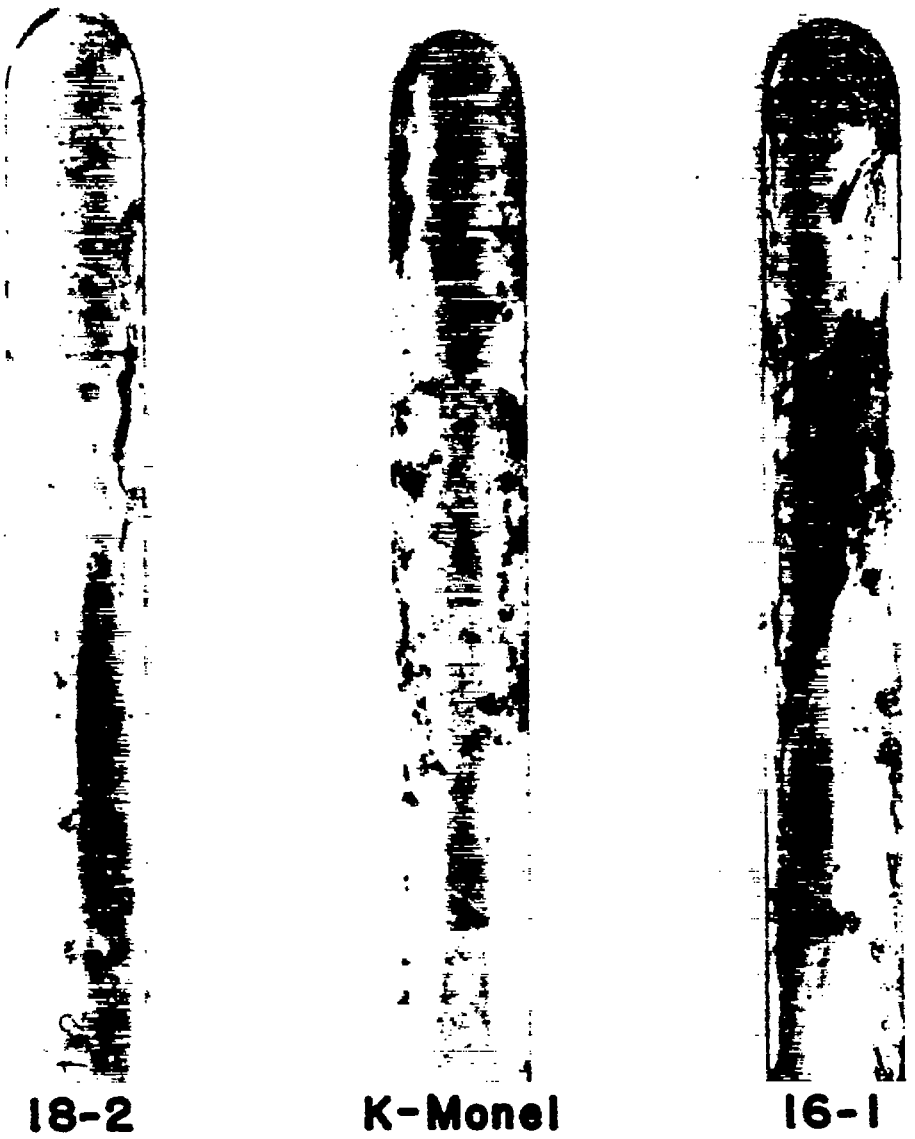
Specimens of tie rods of 18:2, 16:1, and K-monel (O, U, and R) after 300 hours' exposure, in the "as received" condition, to the salt-spray test are shown in figure 15. The corrosive attack on these materials in the salt spray was much more severe than with the plain or stabilized 18:8 materials previously discussed. After 300 hours, there were corrosion pits on all three specimens, the most severe being on the 16:1 material. The three materials would probably stand in the following order with respect to resistance to corrosion in the salt spray: 18:2 (O), K-monel (U), and 16:1 (R).

Figure 15.- 18-2, K-Monel and 16-1 tie-rod specimens after 300 hours exposure to salt spray (20 percent) in the as-received condition. Materials O, U and R. x 1

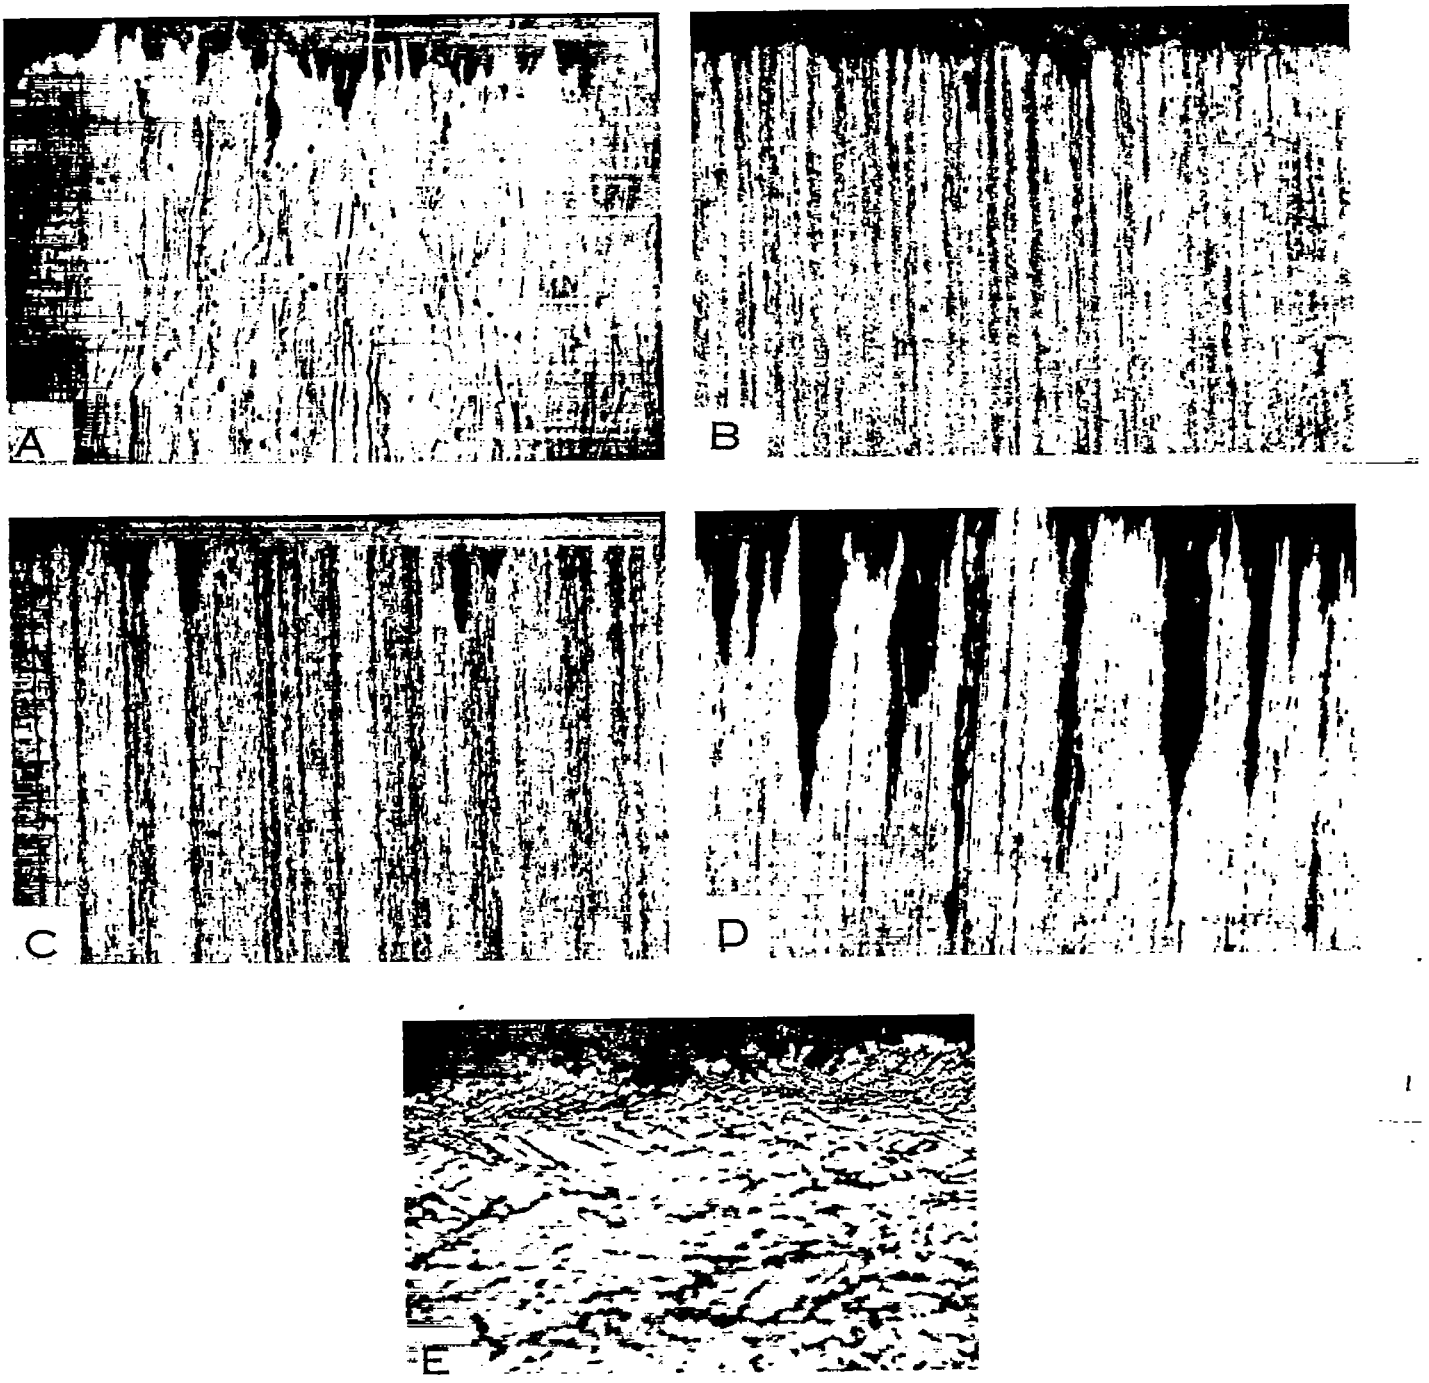
and 1200° F another type of precipitation appeared. The second precipitate apparently occurred in segregated areas, producing a banded structure. The banding is believed to be due largely to chromium-carbide precipitation in segregated areas containing relatively high carbon or little titanium. The segregated bands of heavy precipitation appeared to be areas of lower corrosion resistance (fig. 23 B).

Figure 23.- Corrosive attack in boiling nitric acid;
A, End of 18-8 specimen (Material E), heated 30 minutes at 1000°F. x 100
B, End of 18-8-Ti specimen (Material H), heated 30 minutes at 1300°F. x 100
C, End of 18-8-Cb specimen (Material K), heated 30 minutes at 1200°F. x 100
D, End of 18-8-Mo specimen (Material M), heated 30 minutes at 1100°F. x 100
E, Side of 18-8 specimen (Material E), heated 30 minutes at 1100°F. x 500

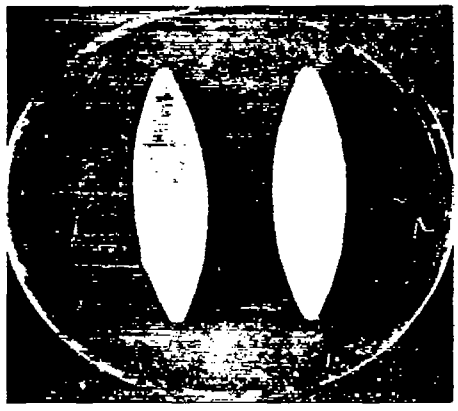
Transverse sections of severely cold-worked tie-rod materials were examined for evidence of the crossed bands often noted during metallographic examinations of such materials. A typical X-band structure in an 18:8 tie rod is shown in figure 34. Similar X bands were found in all the severely cold-worked materials examined (materials A,

Figure 34.- X-bands in transverse sections of 18-8 tie-rods.
Electrolytic etch in 10 percent oxalic acid. x 2
